# GEOTECHNICAL INVESTIGATION

**For:** Phoenix Contracting

**Project Address:** #26 Ford Street, Woodbridge

**Project Number:** D236397

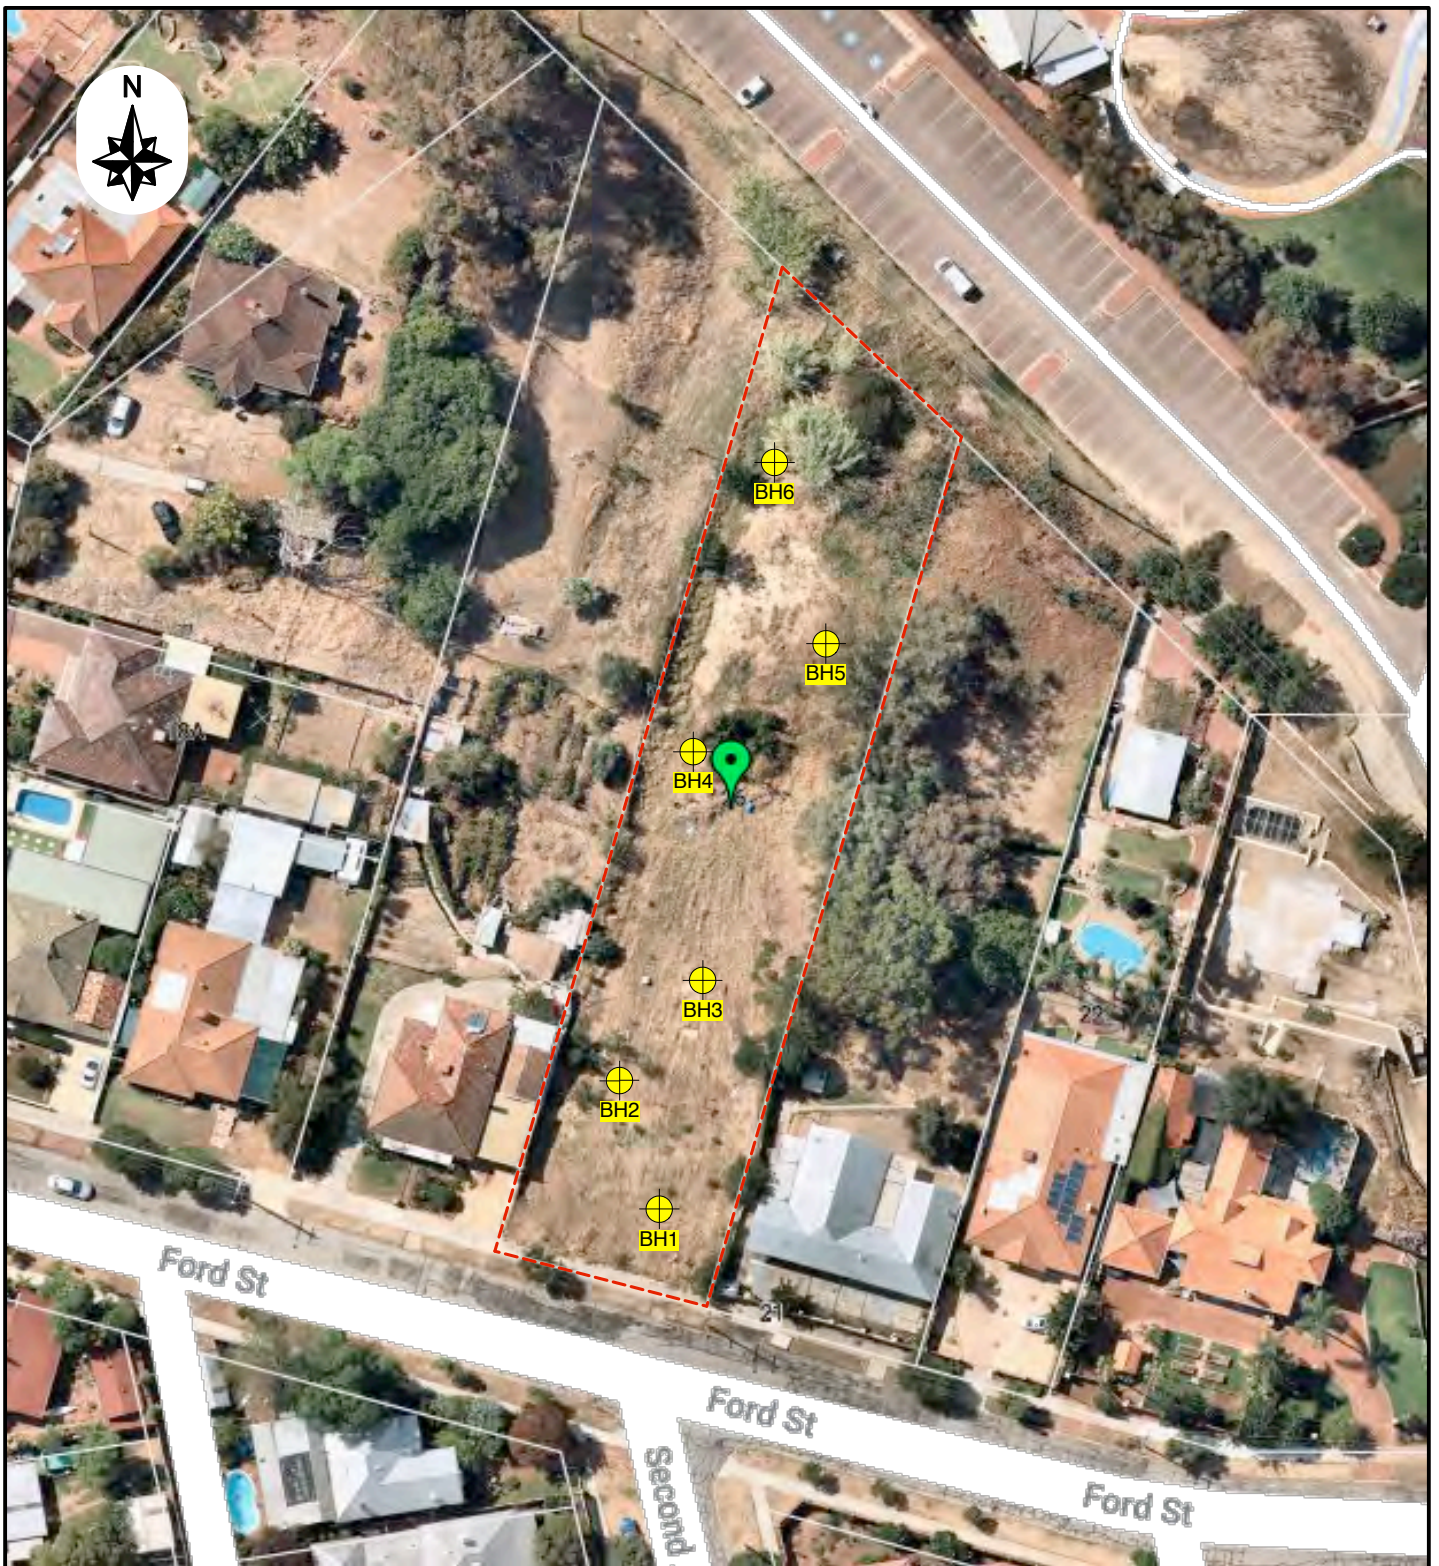
TITLE: Geotechnical Investigation Site Plan

The borehole test locations are shown on the attached site plan in Appendix 1.

Note: Showing approximate test locations only

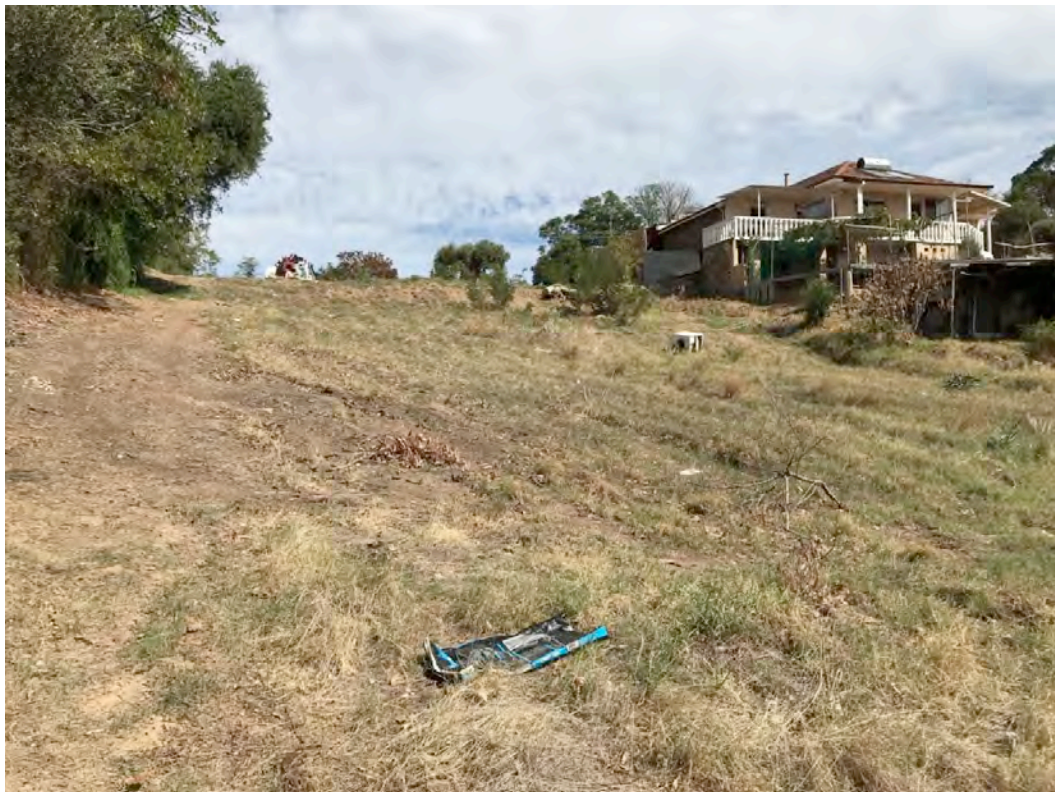
PHOTO 1

The site slopes down towards the rear section. At the time of the field investigation, the site was vacant and covered in vegetation.
